AIR SERVICE INFORMATION CIRCULAR

August 1, 1922

No. 360

REPORT OF STATIC TEST OF THE JUNKER L-6 MONOPLANE

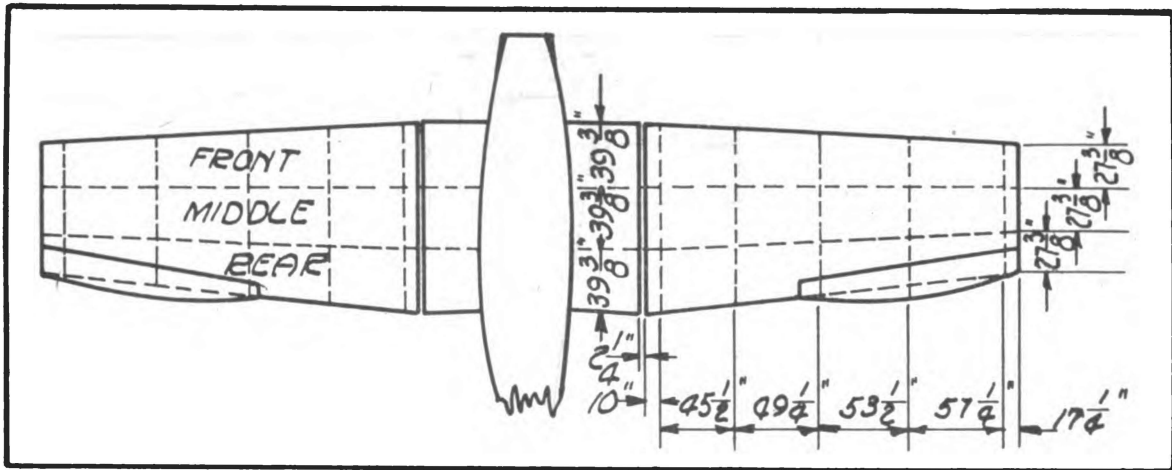
FIG. 3.—JL-6 wing.

LOADING SCHEDULE FOR LOW INCIDENCE ANGLE.

Load factor.	Load (in pounds) over each section of the wings.			Total load on wing.
	F	M	R	
2	580	2,890	2,310	5,780
2.5	740	3,690	2,940	7,370
3	900	4,490	3,570	8,960
3.5	1,060	5,290	4,200	10,550

Wings held and test was discontinued.

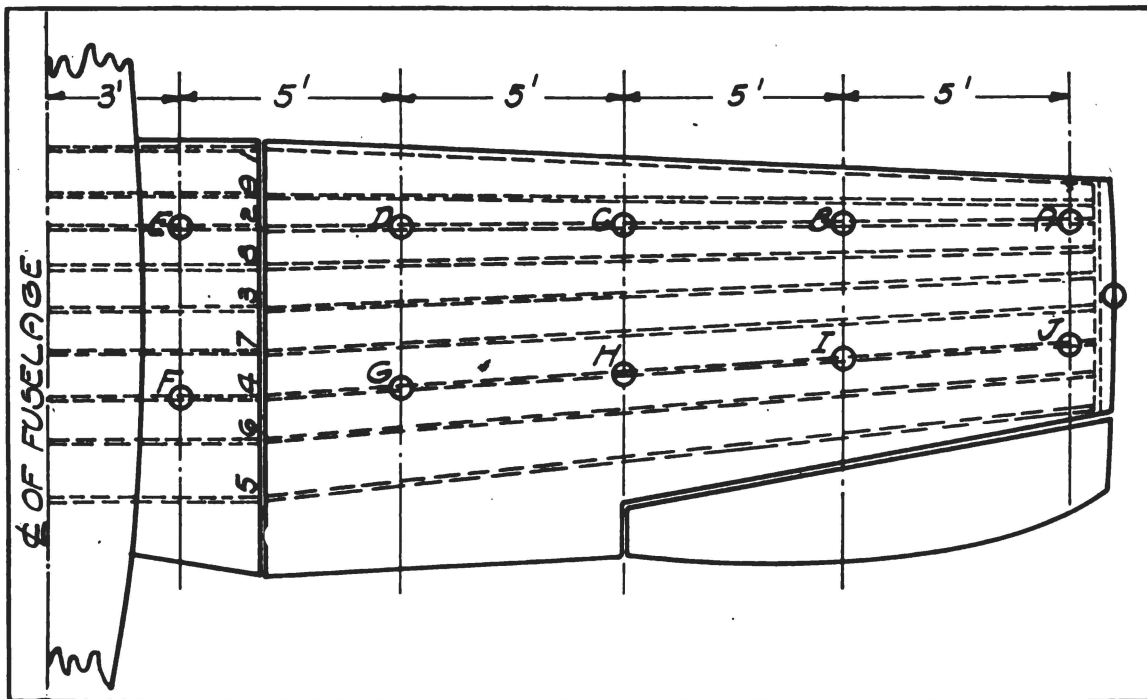
FIG. 4.—JL-6 monoplane.

The deflections and retreat are tabulated in Figure 4 for spars Nos. 5 and 3. Figure 5 shows the deflection curves for the low incidence. Figure 56 is a picture of the low-incidence setting with a part of the load on.

TABLE OF DEFLECTIONS OF THE RIGHT WING FOR THE LOW INCIDENCE ANGLE.

Load factor.	Deflections in inches measured at—										Retreat.
	A	B	C	D	E	F	G	H	I	J	Y
2	4.5	3.2	2.7	1.0	0.5	4.7	3.6	2.3	1.3	0.5	+0.1
2.5	5.8	3.9	2.7	2.4	.6	5.9	4.1	2.8	1.6	.6	+2
3.0	7.1	4.9	3.2	1.7	.6	7.1	5.3	3.4	2.1	.7	+2
3.5	8.5	6.0	3.9	2.0	.8	8.7	6.3	4.1	2.4	.9	-.1

Test discontinued.

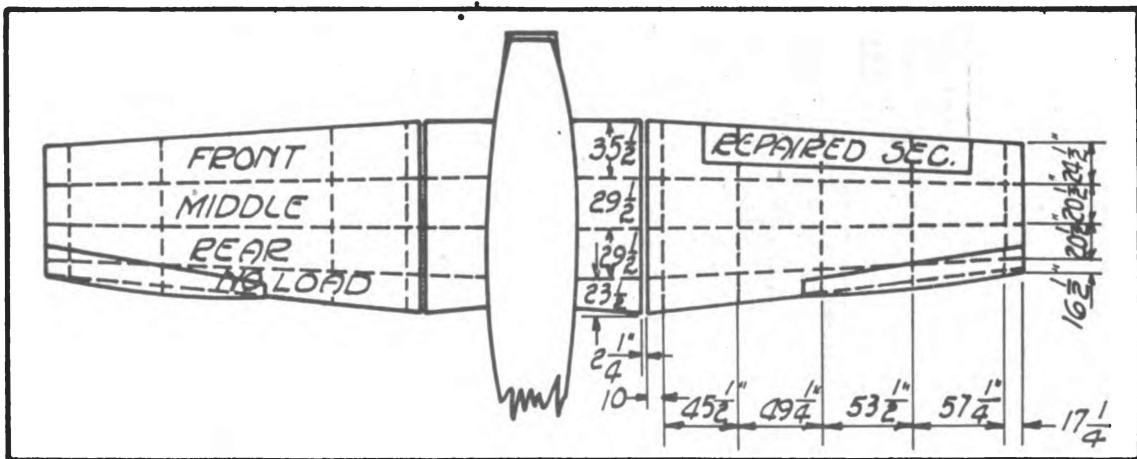
FIG. 6. -JL-6 monoplane.

The deflections are tabulated in Figure 7. Figure 8 is a chart with curves representing the deflections of spars Nos. 4 and 2 at the various load factors. The wings were loaded to a factor of 6.5 when failure occurred.

LOADING SCHEDULE FOR HIGH INCIDENCE ANGLE.

Load factor.	Load (in pounds) over each section of the wings.			Total load on wing.
	F	M	R	
2	2,800	1,450	1,440	5,780
3	4,480	2,230	2,230	8,960
3.5	5,280	2,650	2,620	10,550
4	6,080	3,050	3,010	12,140
4.5	6,880	3,450	3,400	13,730
5	7,680	3,850	3,790	15,320
5.5	8,480	4,250	4,180	17,910
6	9,280	4,650	4,570	18,500
6.5	10,080	5,050	4,960	20,090

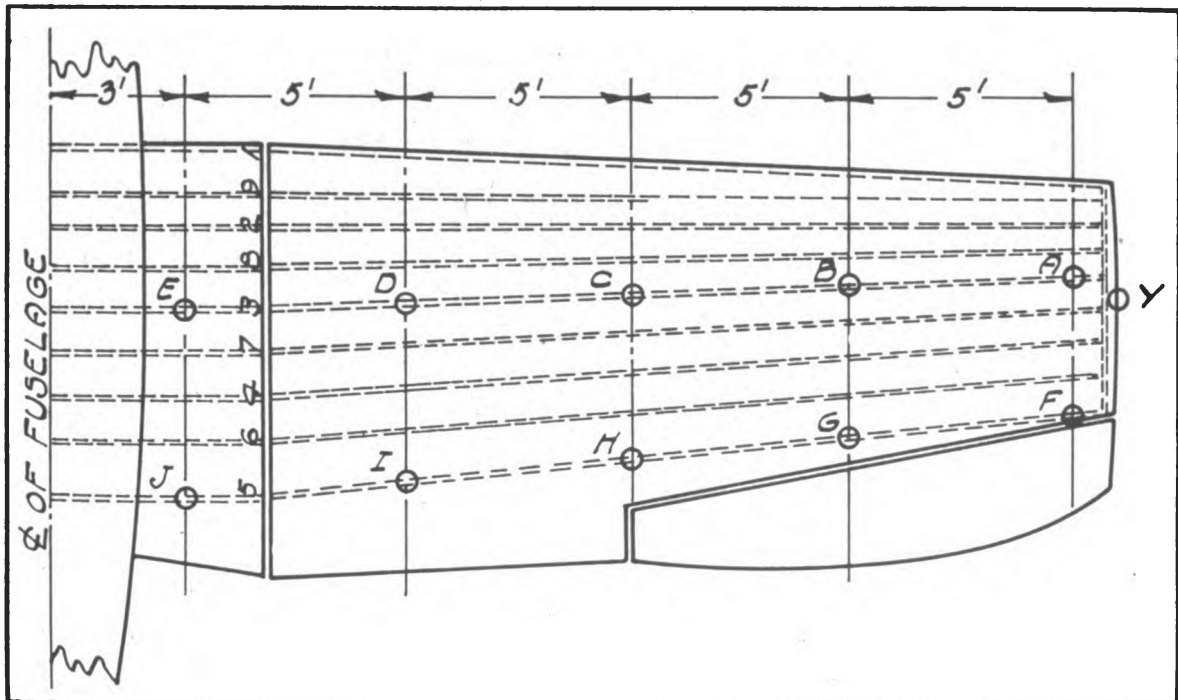
FIG. 7.

TABLE OF DEFLECTIONS OF THE RIGHT WING FOR THE HIGH INCIDENCE ANGLE.

Load factor.	Deflections, in inches, measured at—										Retreat.
	A	B	C	D	E	F	G	H	I	J	Point Y.
2	3.6	2.5	1.5	0.9	0.4	0.6	1.1	2.0	2.9	4.1	+0.8
3	5.5	3.9	2.4	1.3	.5	.8	1.7	3.1	4.5	6.4	+1.4
3.5	6.2	4.3	2.7	1.4	.5	.9	2.1	3.7	5.5	8.0	+1.1
4	7.1	4.9	3.0	1.6	.6	1.1	2.4	4.7	6.4	9.4	+1.3
4.5	8.1	5.7	3.4	1.8	.7	1.2	2.8	5.1	7.5	10.9	+1.5
5	9.6	6.6	4.0	2.0	.7	1.2	3.2	5.8	8.5	12.3	+1.3
5.5	12.7	7.6	4.6	2.3	.9	1.3	3.5	6.5	9.8	13.9	+2.0
6	Deflection readings discontinued. Failure.										
6.5											
7

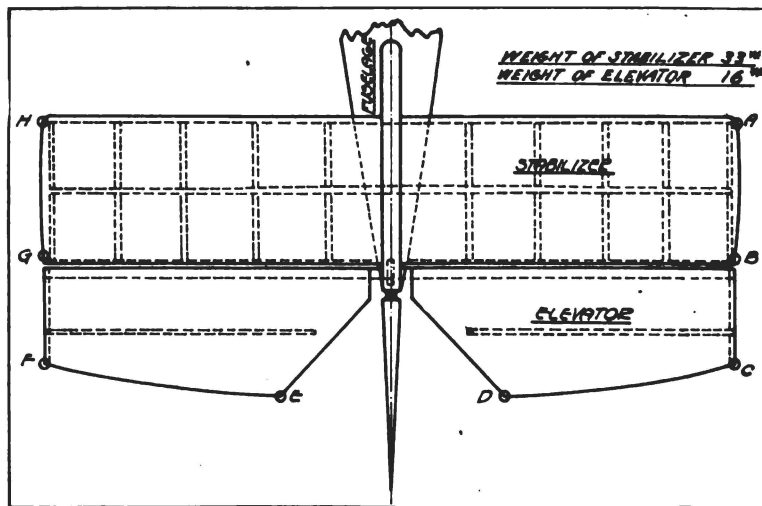
FIG. 21.

RESULTS OF STATIC TEST OF ELEVATOR AND STABILIZER.

Load factor.	Deflections measured at points—								Pull on stick.	Load per square foot on—				Remarks.
	A	B	C	D	E	F	G	H		Elevator.		Stabilizer.		
										Added.	Total.	Added.	Total.	
1	0.1	0.2	0.3	0.1	0.2	0.5	0.3	0.2	Pounds.	Pounds.	Pounds.			Control stick bending control. Stick torque tube failed in bending. Test continued on rear control. Failure of bulkhead supporting walking beam between first and second linkage of elevator control. Both rivets tore loose and the metal tore. Surfaces showed no signs of failure during test.
2	.3	.5	2.1	2.2	2.4	2.1	.7	.3	55	84	84	169	338	
3	.5	.9	4.3	4.8	5.0	4.3	1.1	.6	100	84	168	169	507	
4	1.0	1.2	3.3	5.3	6.7	5.1	1.1	.8	150	84	252	169	686

4.5	1.1	1.0	4.2	6.4	7.9	6.0	1.1	1.4	84	336	169	855	
5	Deflections discontinued.								42	378	84.5	939.5	
5.5	42	420	84.5	1,024.0	
6	42	462	84.5	1,108.5	
6.5	Failure.								42	504	84.5	1,193.0	
									42	546	84.5	1,277.5

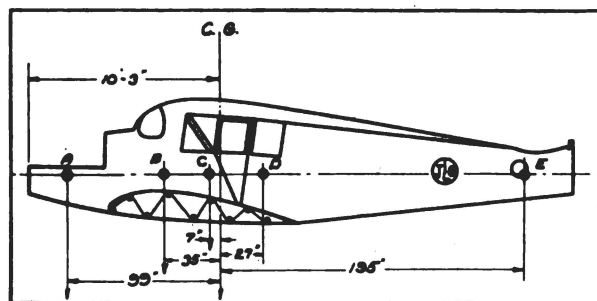
FIG. 36.

LOADING SCHEDULE AND TOTAL LOADS.

Load factor.	Load, in pounds, at—					Total load.	Remarks.
	A	B	C	D	E		
2	1,588	900	460	700	892	4,480	
2.5	1,985	1,125	625	875	1,115	5,725	
3	2,382	1,350	790	1,050	1,338	6,910	
3.5	2,779	1,575	955	1,225	1,561	8,095	
4	3,176	1,800	1,120	1,400	1,784	9,280	
4.5	3,573	2,025	1,285	1,575	2,007	10,465	
5	3,970	2,250	1,450	1,750	2,230	11,650	Fuselage buckled at seams.
5.5	4,367	2,475	1,615	1,925	2,453	12,835	
6	4,764	2,700	1,780	2,100	2,676	14,020	
6.5	5,161	2,925	1,945	2,275	2,899	15,205	
7	5,558	3,150	2,110	2,450	3,122	16,390	Failure; motor support collapsed.

NOTE.—The forward end collapsed before the jacks were free under the load at (E). After the fuselage was counterbalanced the load was imposed at (E). The next failure occurred aft of bulkhead No. 4.

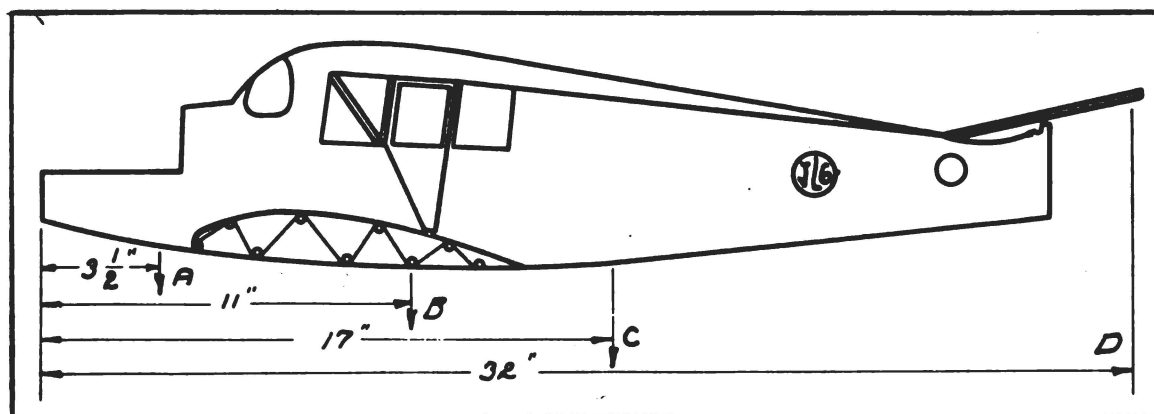
FIG. 37.

A fuselage for an airplane of this type is required to stand a load factor of 5. Although the JL-6 fuselage showed signs of buckling at this loading, it did not fail until a load factor of 7 was imposed. The fuselage of the JL-6 is amply strong and well designed.

Load factor.	Deflections at—				Remarks.
	A	B	C	D	
2	0.3	0.1	0.1	0.3	
2.5	.3	.2	.2	.6	
3	.7	.4	.4	.7	
3.5	.7	.5	.5	.9	
4	.7	.5	.5	1.0	
4.5	.7	.5	.6	1.1	
5	.8	.5	.7	1.4	Fuselage buckled at seams.
5.56	.8	1.6	
66	.9	1.7	
6.5	Deflections discontinued.				
7	Failure.				Engine support collapsed.
7.5	Failure.				Rear part of fuselage collapsed.

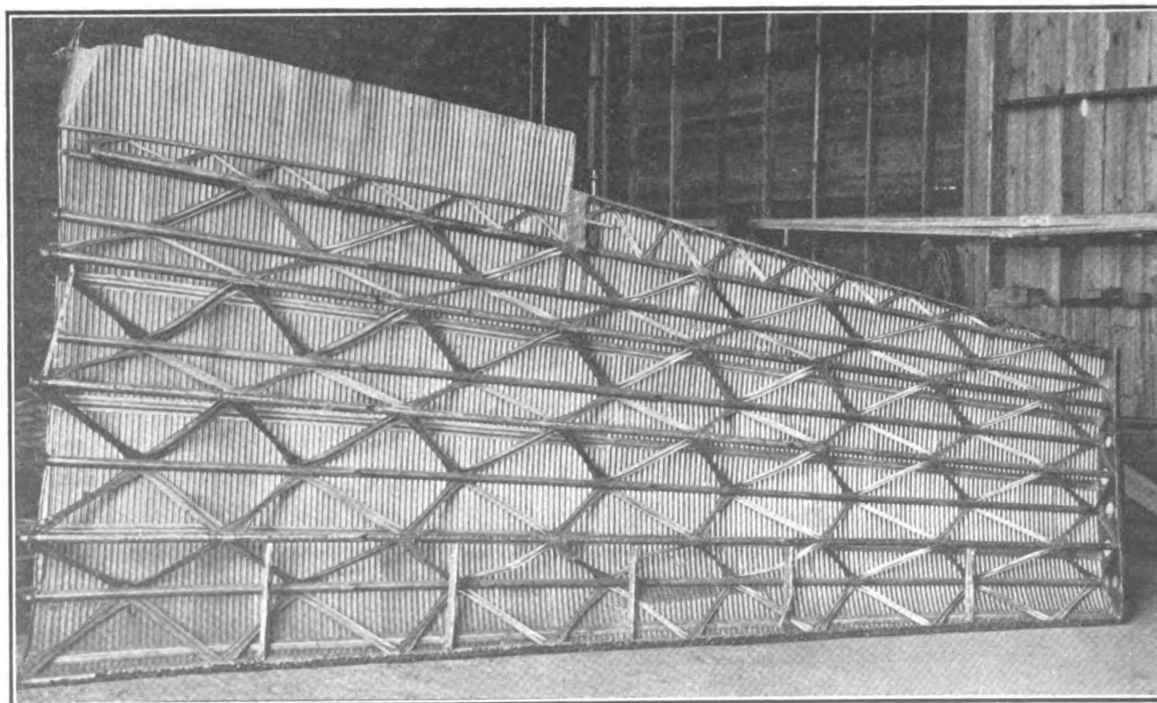
FIG. 54.

Figures 11 and 12 show the method of bracing. Figure 13 shows the cross section of the corrugated braces used. Figure 54 is a photograph of the wing with half the wing cover removed.

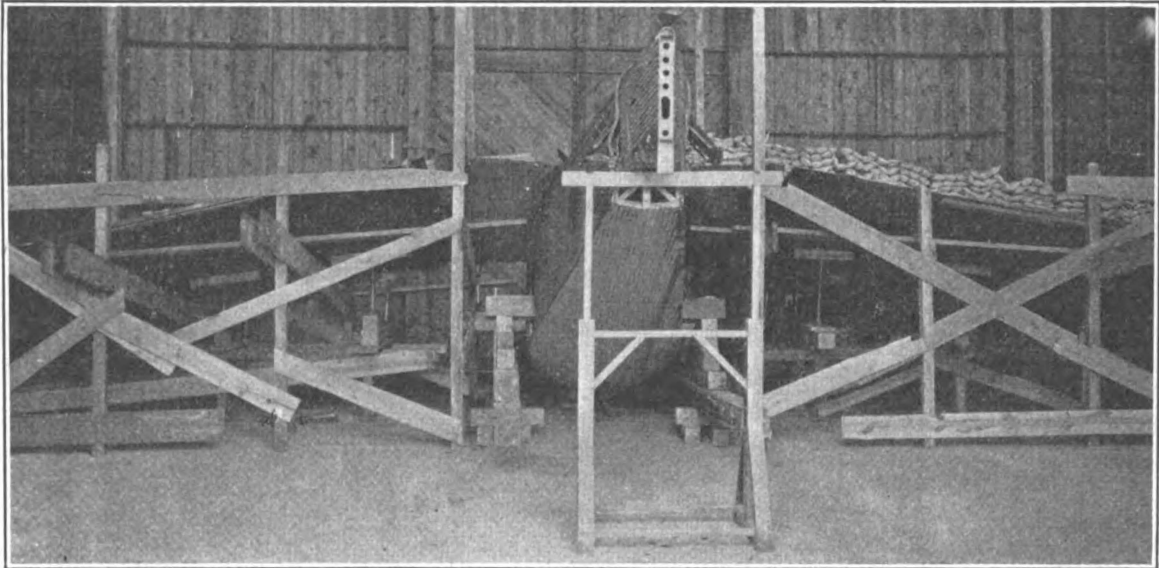
FIG. 57.

Figures 57 and 58 are pictures of the high incidence set up with the load on.

however, but on the repaired wing it was piled higher and along the center of the wing, which makes it appear in the picture (fig. 57) to be loaded heavier on this wing than on the other.

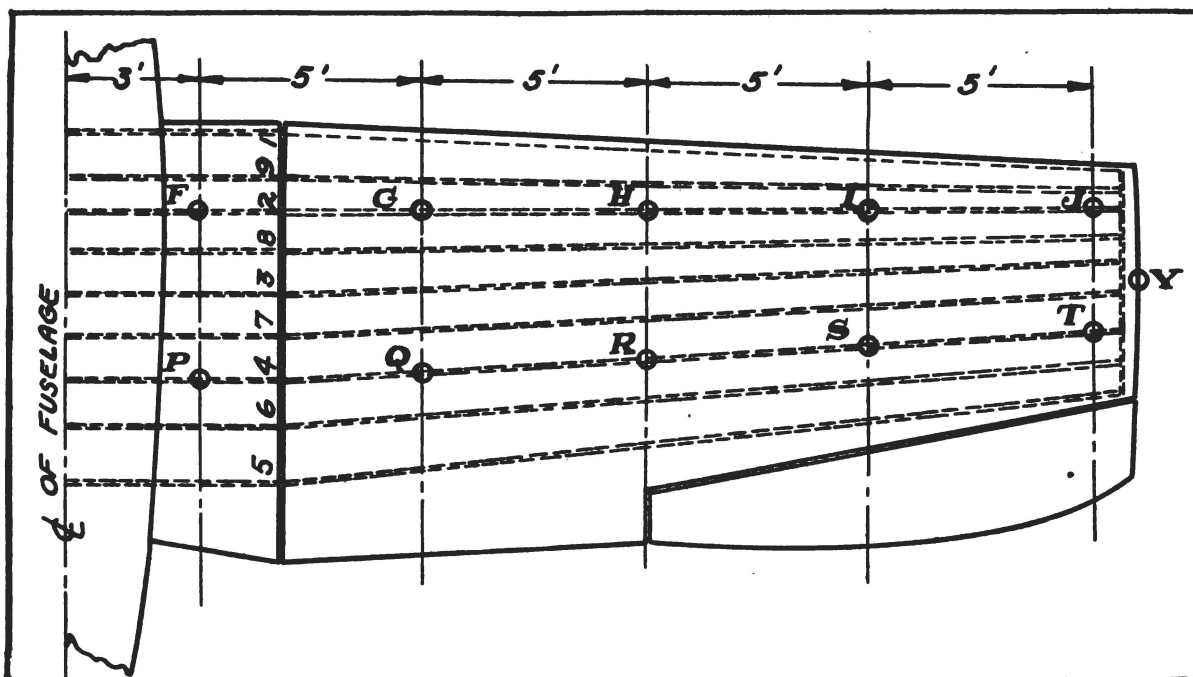
FIG. 7

TABLE OF DEFLECTIONS OF RIGHT WING FOR HIGH INCIDENCE

Load factor	Deflections in inches at—										Retreat
	Front spar					Rear spar					
	F	G	H	I	J	P	Q	R	S	T	Point Y
2.0.....	0.6	1.1	2.0	2.9	4.1	0.3	0.9	1.8	2.9	4.1	+0.8
3.0.....	.8	1.7	3.1	4.5	6.4	.5	1.6	2.9	4.5	6.4	+1.0
3.5.....	.9	2.1	3.7	5.5	8.0	.6	1.9	3.5	5.5	7.8	+1.1
4.0.....	1.1	2.4	4.4	6.4	9.4	.8	2.3	4.1	6.6	9.3	+1.3
4.5.....	1.2	2.9	5.1	7.5	10.9	1.0	2.6	4.8	7.5	10.7	+1.5
5.0.....	1.2	3.2	5.8	8.5	12.3	1.2	2.9	5.5	8.4	12.2	+1.8
5.5.....	1.3	3.5	6.5	9.8	13.9	1.2	3.1	6.3	9.6	13.7	+2.0
6.0.....	Deflection readings discontinued.										
6.5.....	Failure.										
7.0.....

Page 10, Figure 7, substitute the following:
